TECHNICAL REPORT NO. LWL-CR-06C66A

AIRCRAFT MOUNTED PERSONNEL DETECTOR CHEMICAL

Final Phase IV Report
Contract No. DA-18-001-AMC-983(X)

By
Ordnance Systems
General Electric Company
Pittsfield, Massachusetts 01201

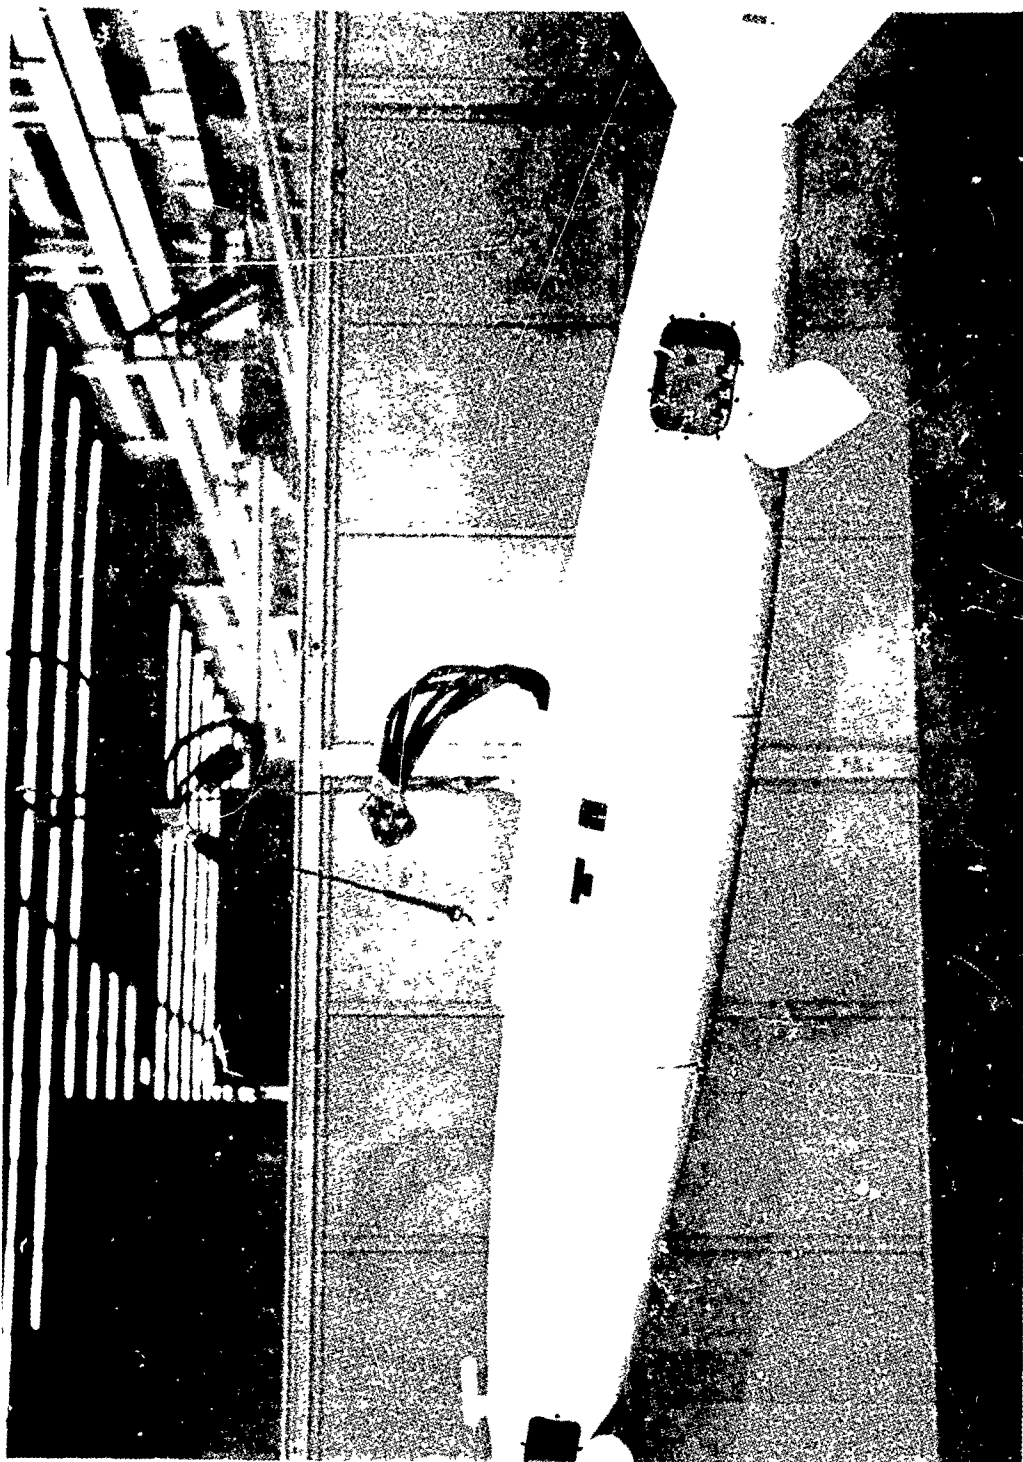
Figure 3-12. Pod 1 Weight and Center of Gravity Determination (View Left Side).

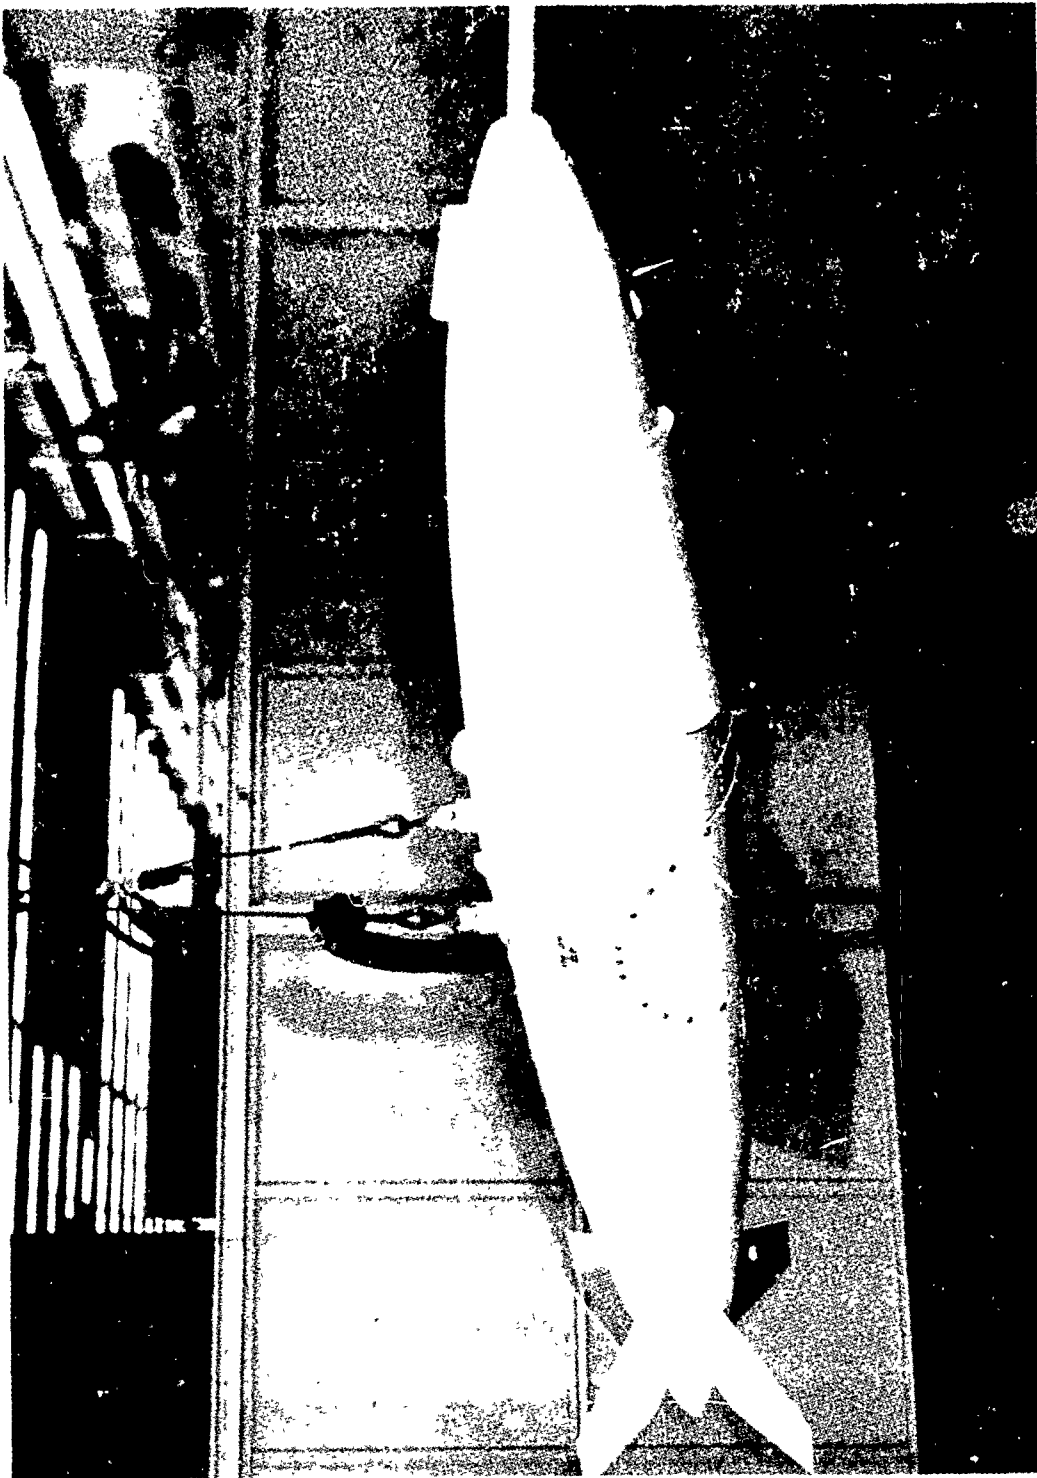
Figure 3-13. Pod 2 Weight and Center of Gravity Determination.

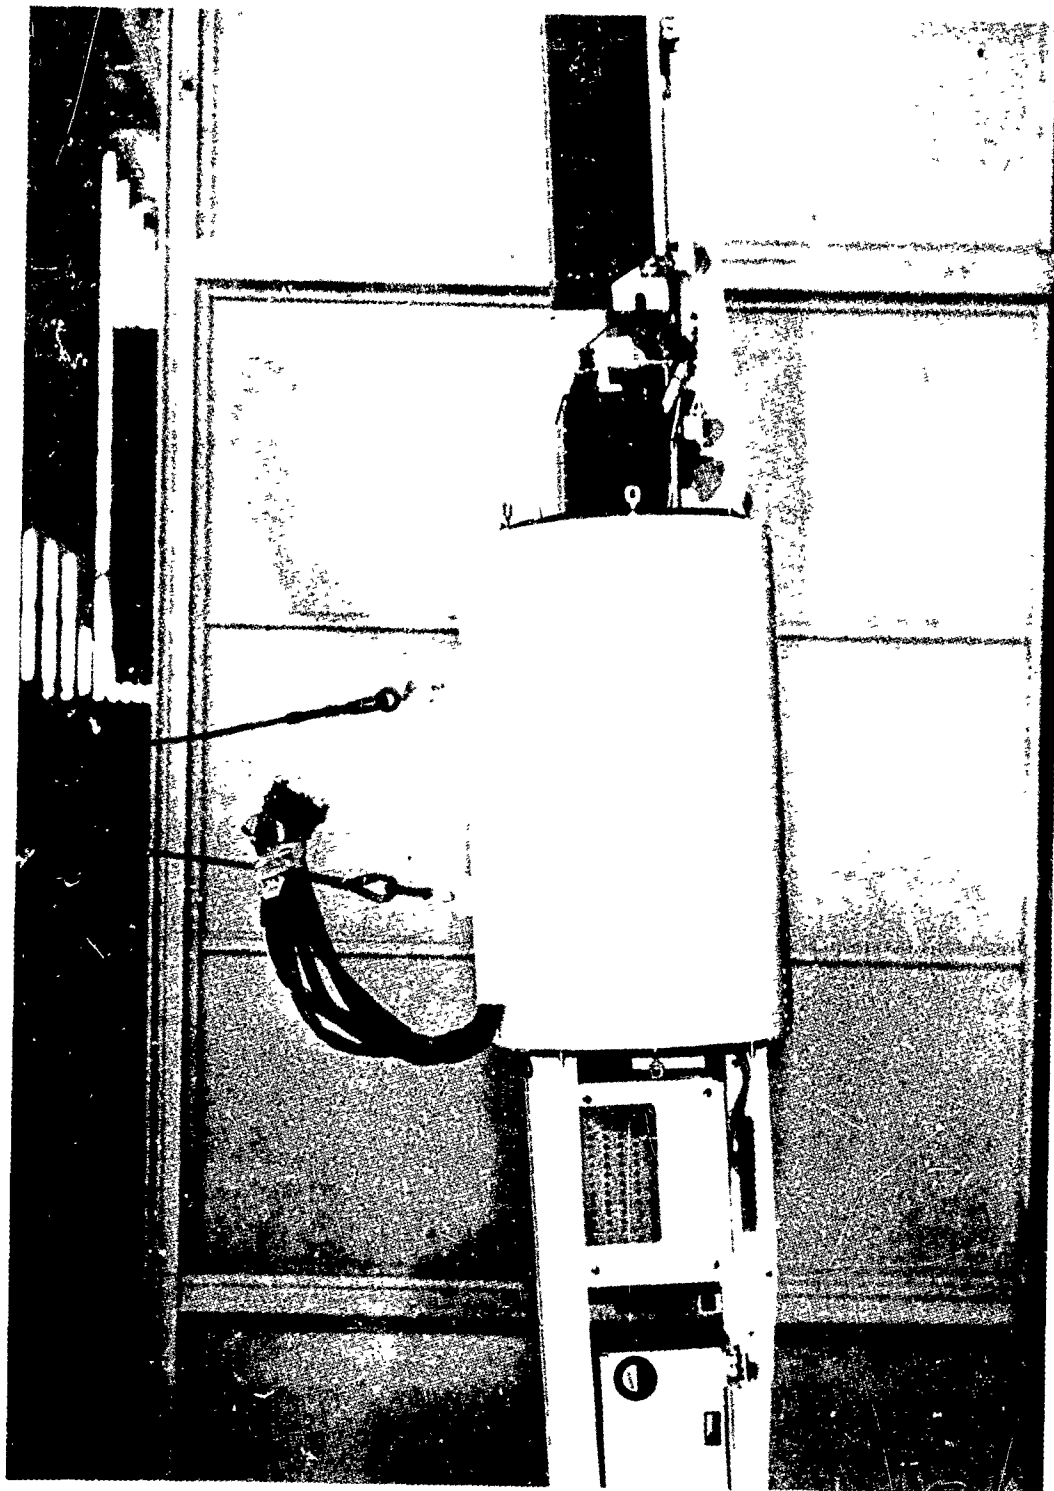
Figure 3-14. Pod 1 Weight and Center of Gravity Determination End Sections Removed (View Right Side).

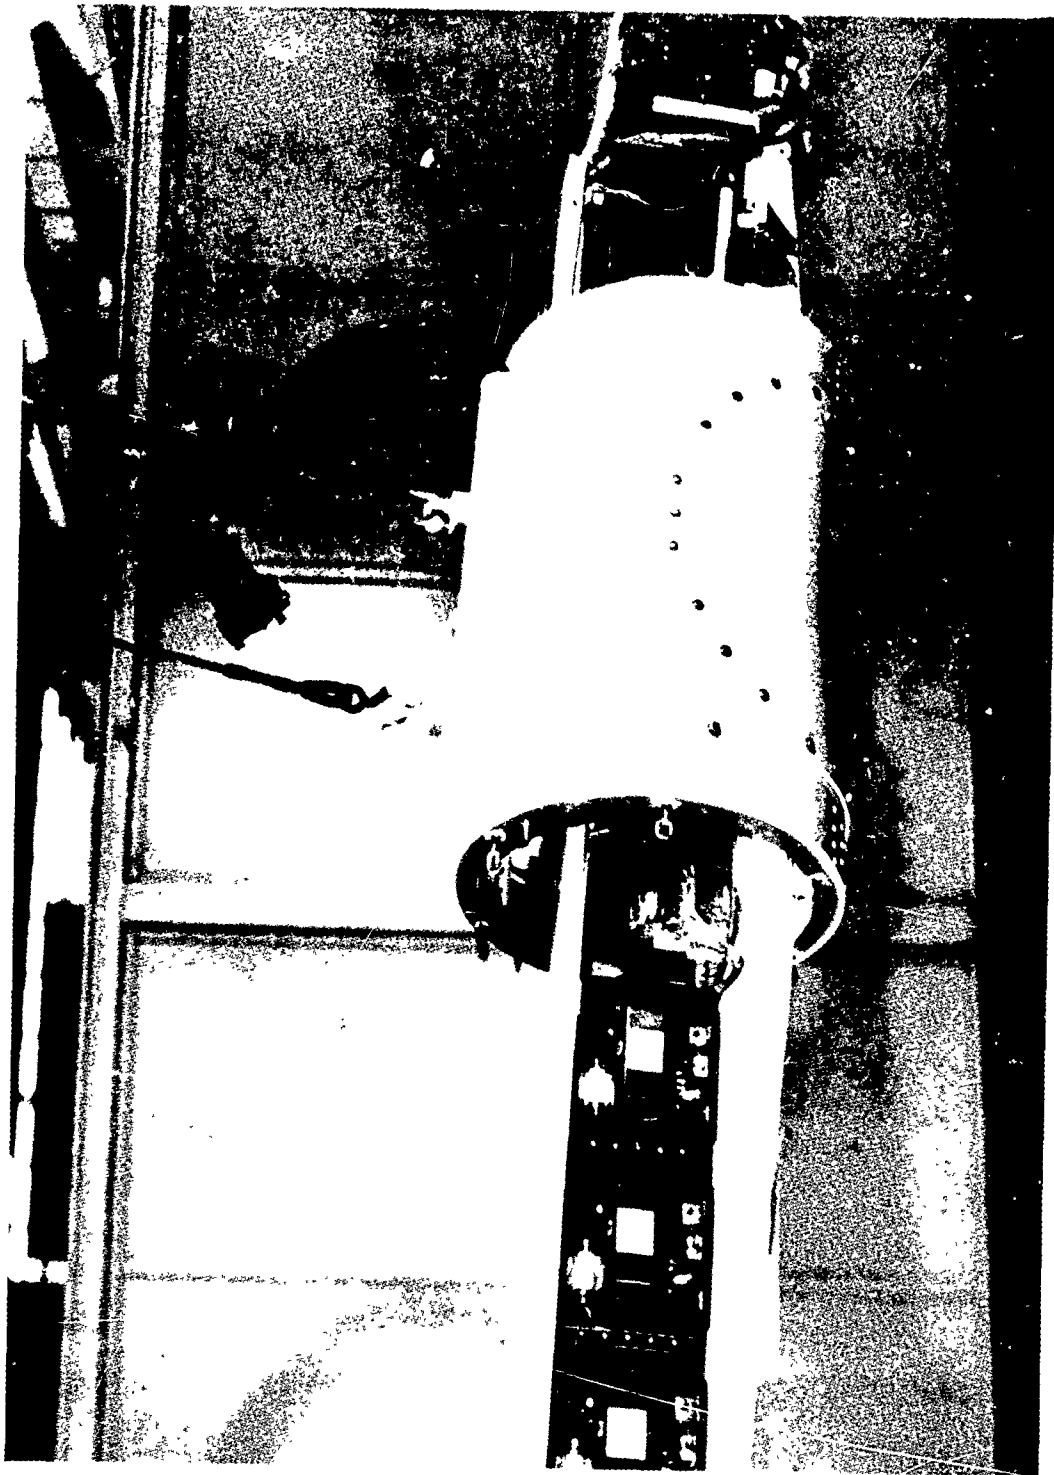
Figure 3-15. Pod.2 Weight and Center of Gravity Determination End Section Removed (View Left Side).

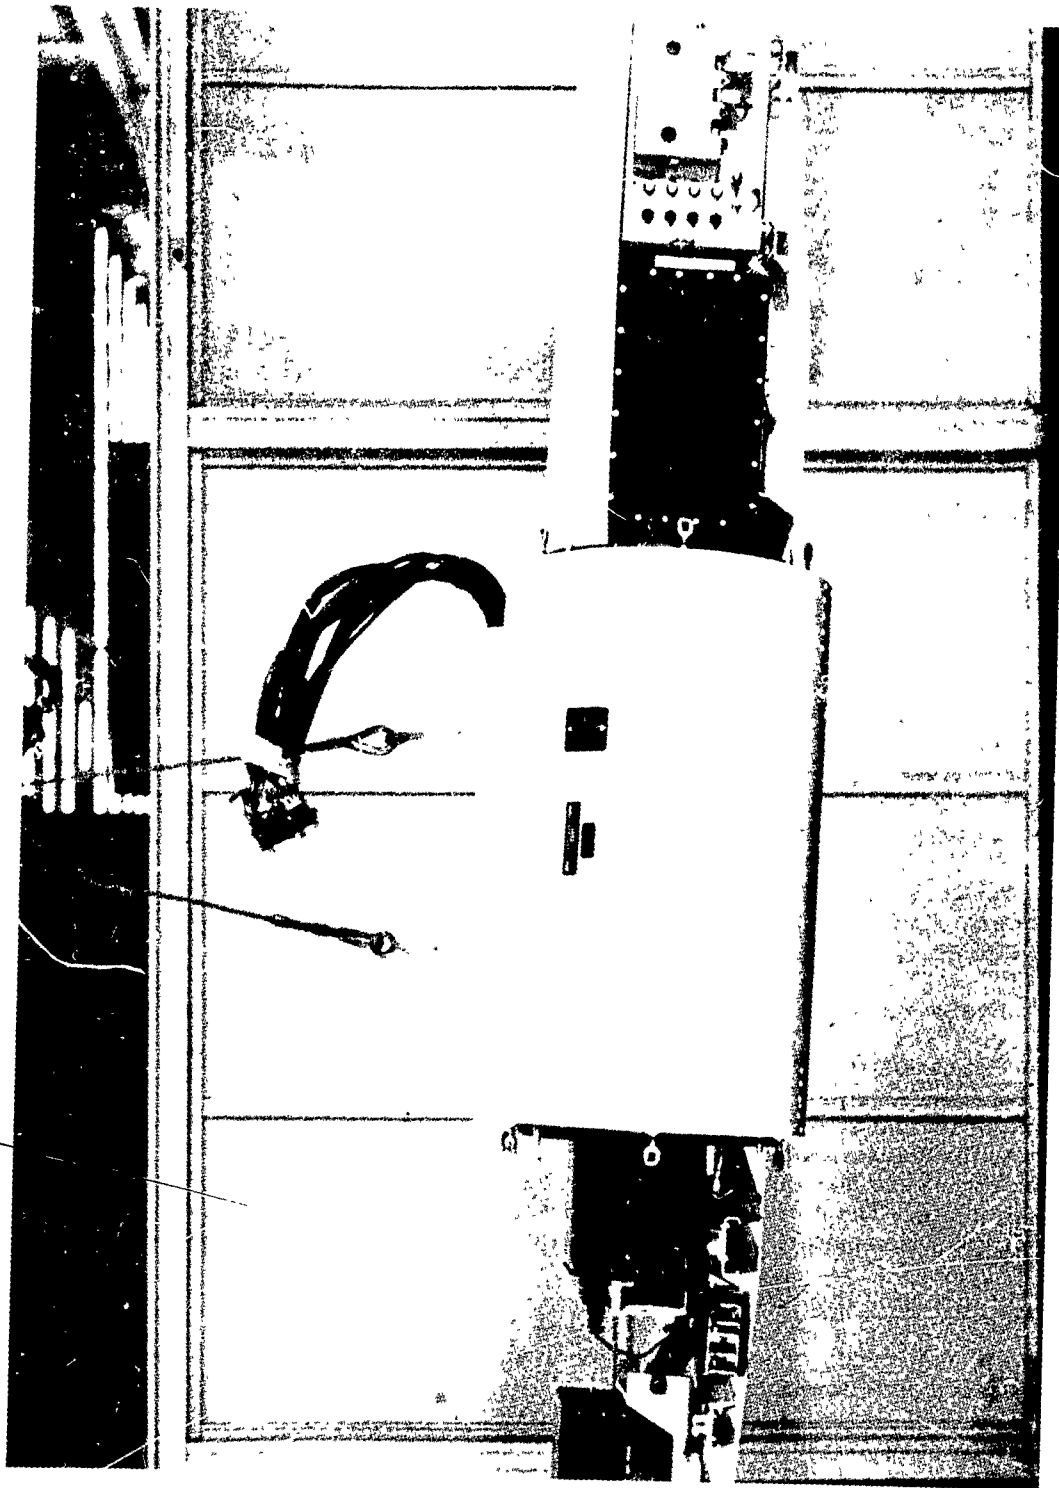
Figure 3-16. Pod 1 Weight and Center of Gravity Determination End Section Removed (View Left Side).

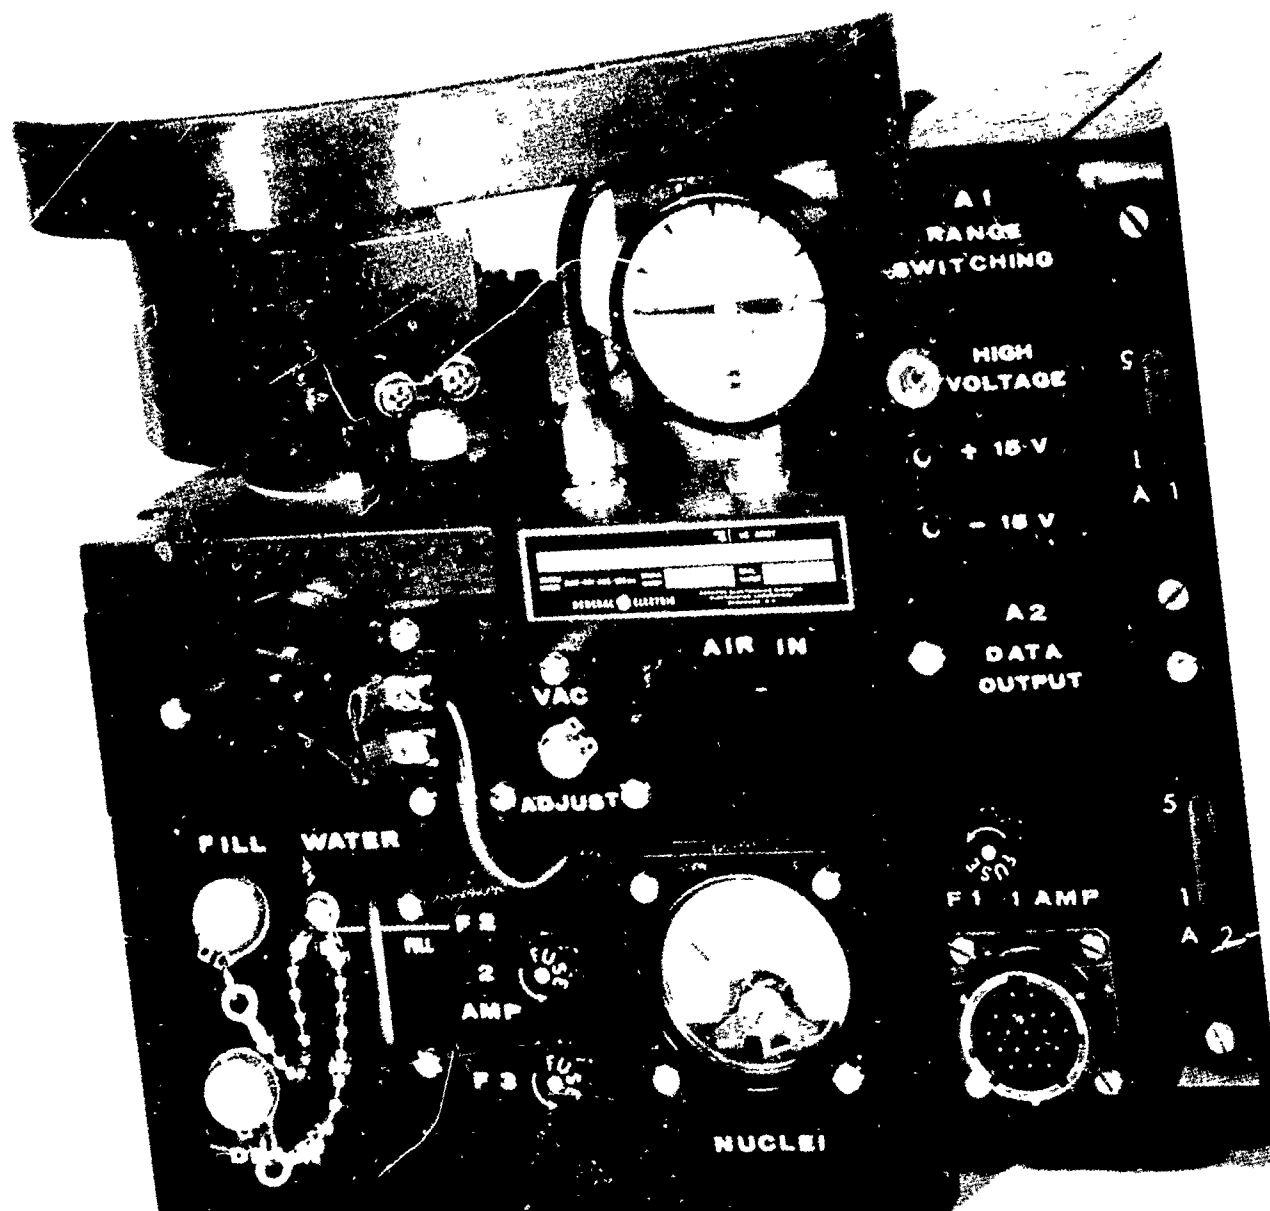
Figure 3-17. Detector Assembly.

Late in the program, it was decided that a single logarithmic scale for the detector would be desirable instead of three linear switched scales. A new circuit was developed with a single logarithmic scale, 50 thousand particles per cc full scale, and has been installed in most equipments. The approach employed was to utilize the logarithmic characteristic of a diode in the feedback loop in an operational amplifier to yield a logarithmic gain characteristic. The major problem associated with this approach was the temperature dependence of the diode characteristic. A satisfactory solution was to use the base-emitter diode junction in a ua726 integrated circuit device, which maintains a constant internal temperature through internal sensing and power dissipation. See para 2.2.13 for further detail on the log amplifier modification. Figure 3-17 shows the detector assembly.
